Reconnaissance Survey of the
Historical Bridgeport Disposal Site
August 1992

Disposal Area Monitoring System DAMOS

Contribution 107
January 1996

Report No.
SAIC-C109

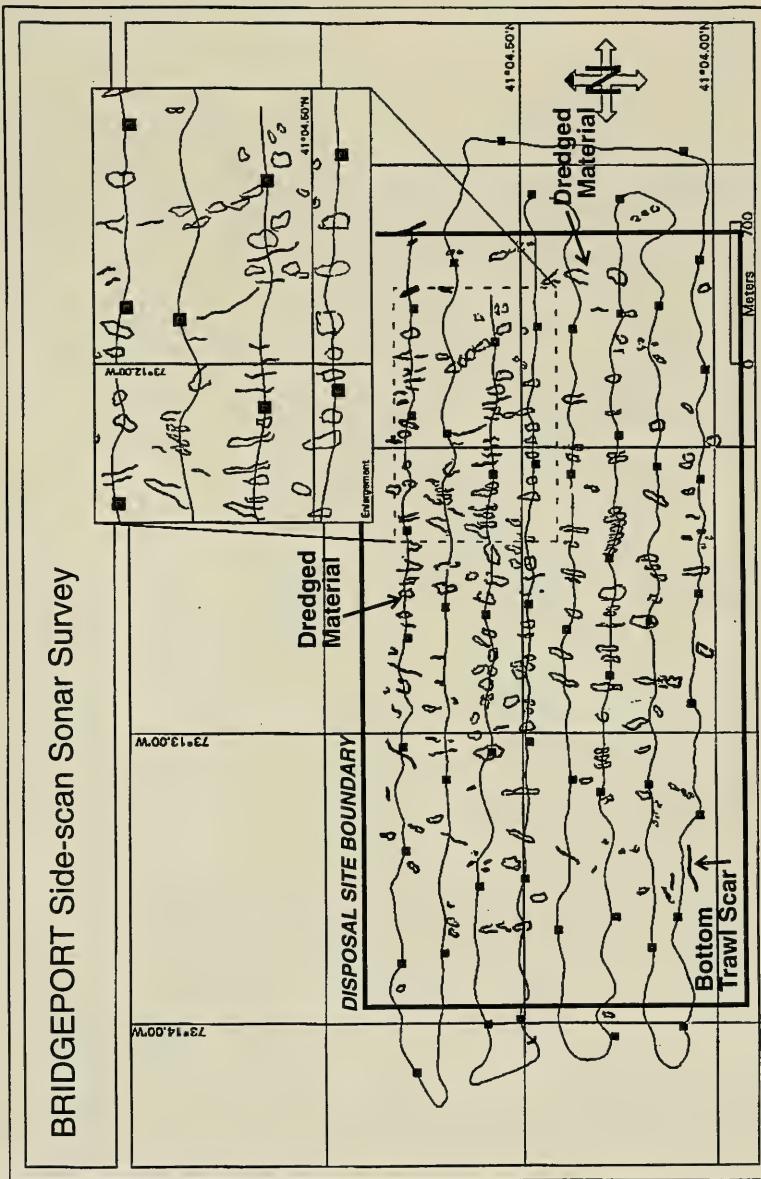
Figure 2-2. Bridgeport Disposal Site side-scan sonar survey mosaic. Annotations are outlines of visible features, as labelled on the example features.

The speed of the vessel was maintained at 3 knots while the sonar (i.e., towfish) was towed approximately 11 m from the seafloor. During the survey, the navigation system generated a plot of the ship's position with respect to the target survey lanes (Figure 2-1). Time was automatically annotated on the plot every 5 minutes. At the same time, the sonar record was annotated with time so that targets present on the sonar record could be transferred (compensating for cable layback) to the real-time navigation plots following the survey. The resulting mosaic of acoustic targets was used to establish the locations of the REMOTS® stations (Figure 2-2).

The habitat quality of infaunal benthos within the disposal site was, in general, stable. The average OSI for all stations was +7, and the presence of Stage III deposit-feeding assemblages indicated the benthic environment was relatively healthy. Among the 13 stations analyzed using REMOTS®, however, OSI values were not consistently high, nor were Stage III fauna present at every station. The OSI values at Stations B22, B23, B29, and B30 were less than +6 due to the presence of Stage I fauna only and the relatively low RPD depths (Figure 4-1). Two of these stations (B22 and B23) were stations where no dredged material was present (Figure 3-6), indicating no correlation between the presence of dredged material and OSI. In the remaining stations, the OSI values were high, ranging from +7 to +11, because Stage III organisms were present. High OSI values occurred even though the RPDs for these stations were relatively shallow. Although REMOTS® data indicated a healthy benthic community overall, recolonization was somewhat patchy in the area surveyed. The patchy distribution of Stage III assemblages may be caused by bottom trawling activities that disrupt the sequence of infaunal recolonization, or by long-term impact from contaminated dredged material. Both the scattered pattern of trawl marks and dredged material deposits are evident in the side-scan record at Bridgeport (Figure 2-2).

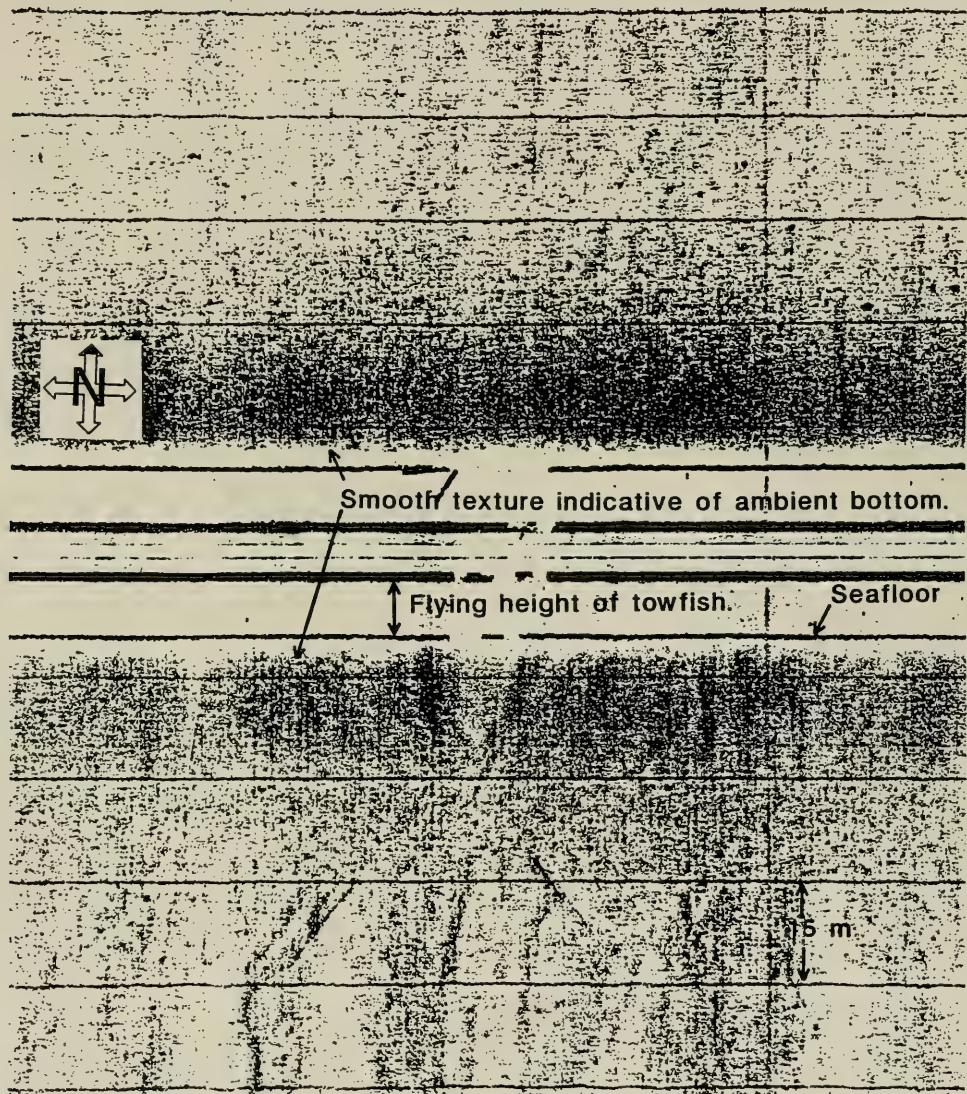
Figure 3-1. Example of a side-scan sonar record from the western portion of lane 2 showing the smooth, featureless image produced by the ambient silt bottom

The historical Bridgeport Disposal Site, based on the results of the side-scan survey, is mottled with relic, low-relief dredged material deposits. The natural or ambient bottom in the western portion of the site exhibits a predominantly smooth, low-reflectance, silty texture (Figure 3-1). Numerous low-relief, high-reflectance features, inferred to be dredged material, are present throughout the disposal area but are concentrated in the central portion of the site (Figure 3-2). The mottled, patchy appearance of these strong acoustic reflectors, or targets, is characteristic of dredged material deposits and is due to alternating patches of high- and low-reflectance materials. Strong reflectance of dredged material deposits relative to the ambient, smooth bottom is a function of increased acoustic backscattering at the surface of the deposit. This backscattering is likely related to increased microtopography and surface roughness (i.e., coarse-grained texture) of dredged material in comparison to smooth, ambient sediments. While storm activity may reduce the topographic relief of dredged material mounds, net deposition in Long Island Sound is slow, approximately 1 mm/yr. Coarse-grained dredged material covered by a thin surface deposit may be sonically detected with side-scan sonar which has a small degree of bottom penetration.

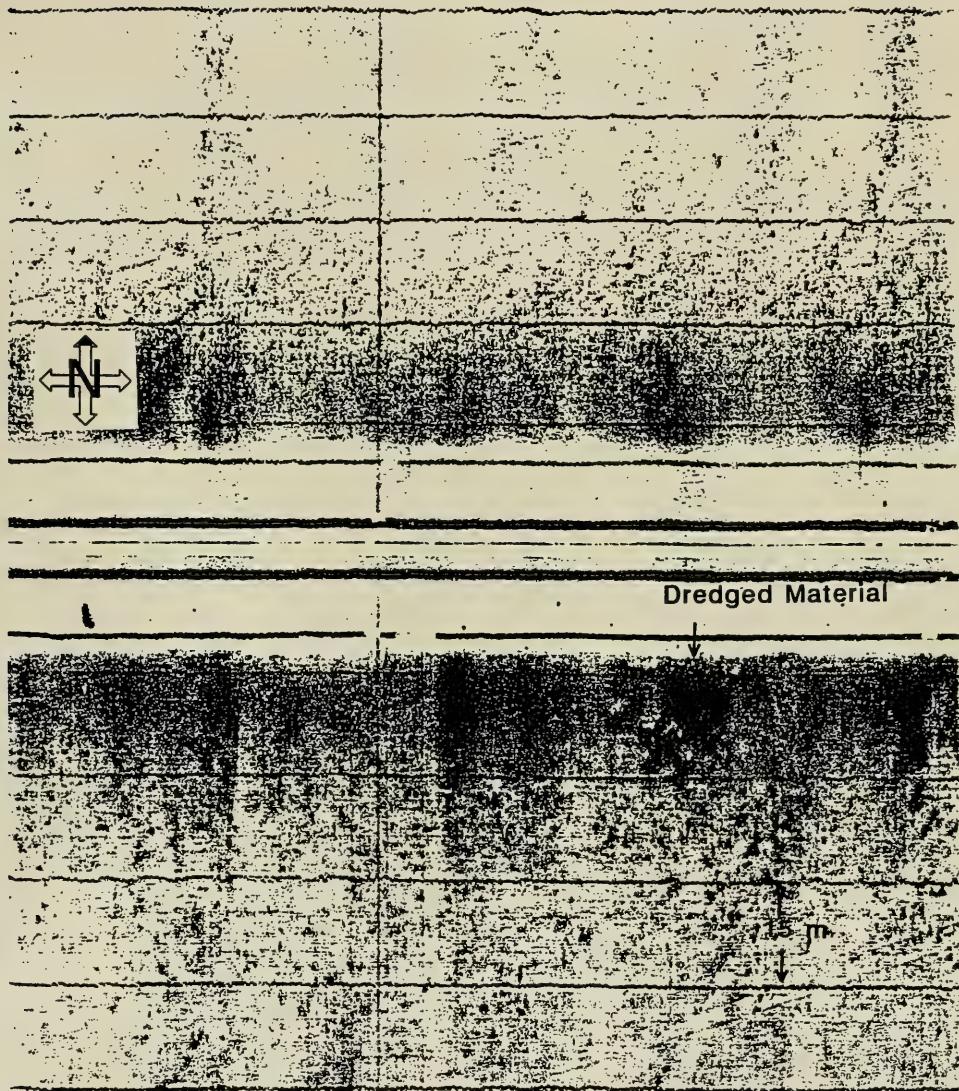
Figure 3-2. Example of a side-scan record from the eastern portion of lane 7 exhibiting mottled texture and low-relief patches of high-reflectance areas on low-reflectance ambient bottom

Recently deposited dredged material will typically form a localized, circular high-reflectance pattern in side-scan sonar traces (SAIC 1987, 1990c). The mottled appearance and low relief of dredged material in this survey suggest that the acoustic reflectivity of the material has decayed due to physical or biological reworking of the deposit or that natural deposition over the last fifteen years has covered portions of the relic dredged material.

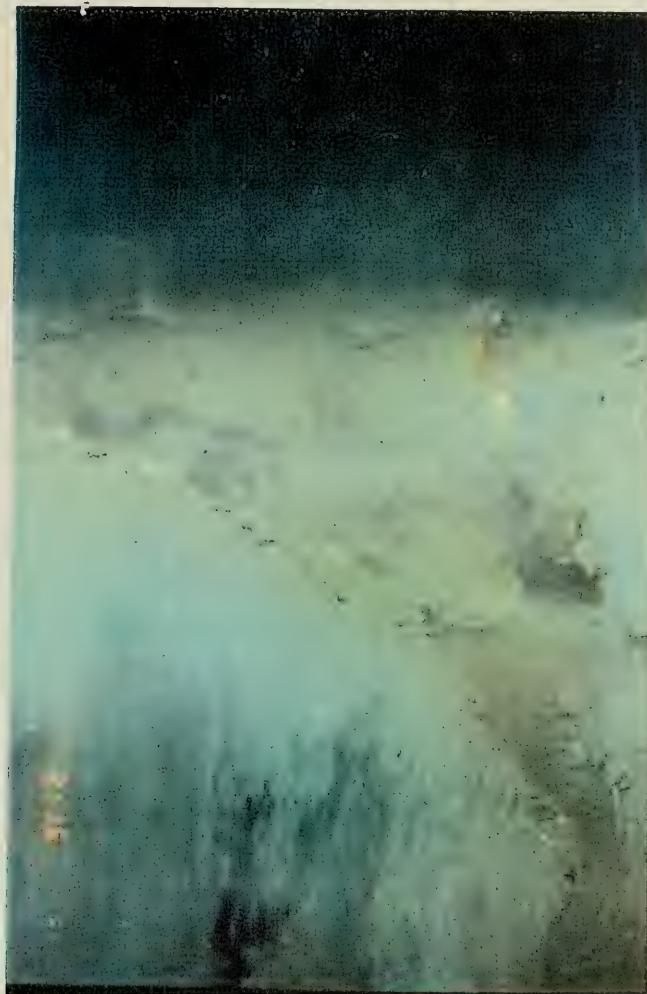
Figure 3-3. Bridgeport Disposal Site REMOTS® photograph from Station B21/C showing surface shell fragments and mud clasts. The large burrow may be that of a lobster. Scale = 1.0×.

Some stations exhibiting relatively high modal grain sizes (1 or less) also contained shell fragments and mudclasts. Shell fragments were present in 25 percent of the Bridgeport photographs, and mudclasts were present in 50 percent of the REMOTS® photographs (Figure 3-3). Mud clasts are typically associated with the reduction of topographic relief due to physical and biological processes. While fine-grained sediment is reworked into ball structures and concentrated in topographic lows, coarse-grained materials, including shell fragments, are concentrated at the crest of the gradually decaying mound (SAIC 1984). Localized disturbances, such as trawling activities, may also disturb relic dredged material and initiate the formation of small mud clasts. Evidence of trawling was noted on the side-scan records (Figure 3-4).

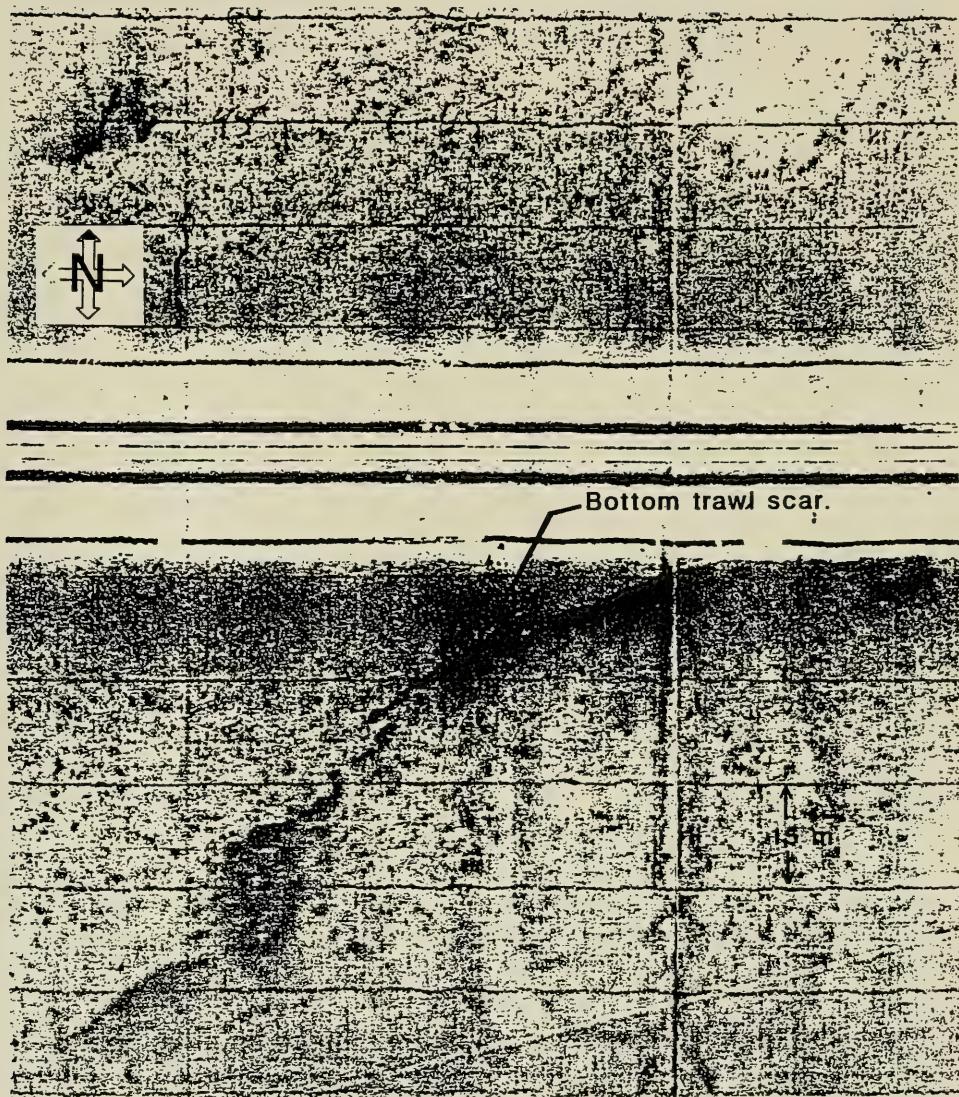
Figure 3-4. Example of a side-scan record (lane 9) showing evidence of bottom trawling

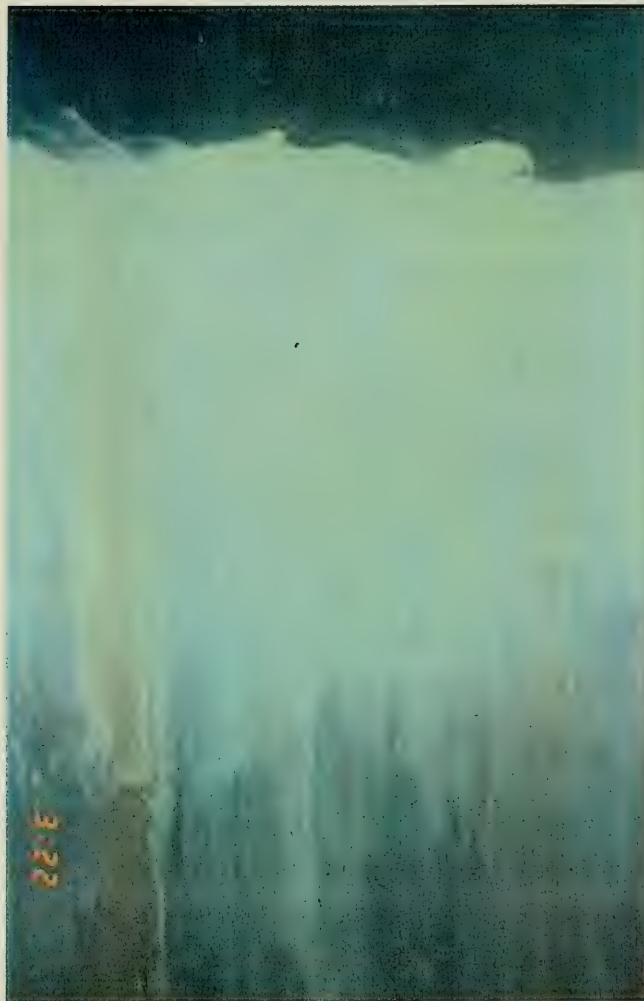
Figure 3-5. Bridgeport Disposal Site REMOTS® photograph from Station B28/B exhibiting Stage I on III infauna. In this photograph, dredged material is greater than the camera prism penetration depth. Note the backfilled infaunal burrow.
Scale = 1.0X.

Both Stage I and Stage III infaunal successional stages were observed at the Bridgeport Disposal Site. Stage I infauna were frequently observed in the same photograph as Stage III head-down deposit feeders (as evidenced by feeding voids) (Figure 3-5). At three stations, Stage I benthos were observed exclusively, and two of these stations were interpreted to be ambient. The area, overall, was apparently occupied by Stage III infaunal benthos which typically inhabit low disturbance regimes.

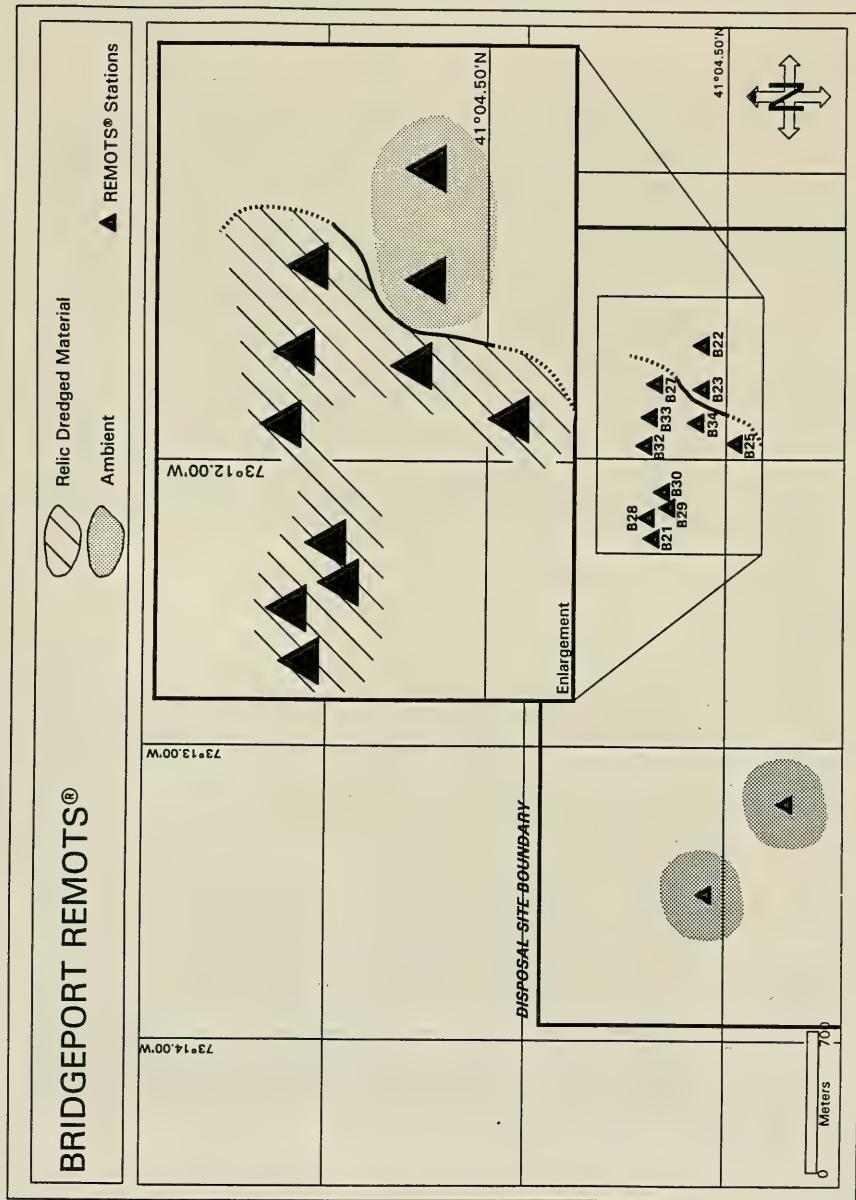
Figure 3-6. Relic dredged material distribution at the Bridgeport Disposal Site

Relic dredged material was detected in nine (B21, B28, B32, B33, B27, B29, B30, B34, and B25) of the 13 stations occupied (Figure 3-6). Dredged material was recognized by its coarse-grained, slightly reduced texture (Figure 3-7). Shell fragments were also observed. Relic dredged material did not contrast sharply with ambient sediments in terms of sediment color, reflectance, apparent RPD depth, or infaunal successional stage. Dredged material layers ranged in thickness from 12 to 18 cm and frequently exceeded the camera prism penetration depth. This indicates either that dredged material has remained in layers of this thickness in the area surveyed or that relatively thin dredged material layers have been buried with time by natural sedimentation. Two stations, B22 and B23, were characterized by ambient sediment (Figure 3-6). Both possible relic dredged material and ambient sediment were observed in some, but not all, of the replicate photos collected at the two westernmost stations, B26 and B24.

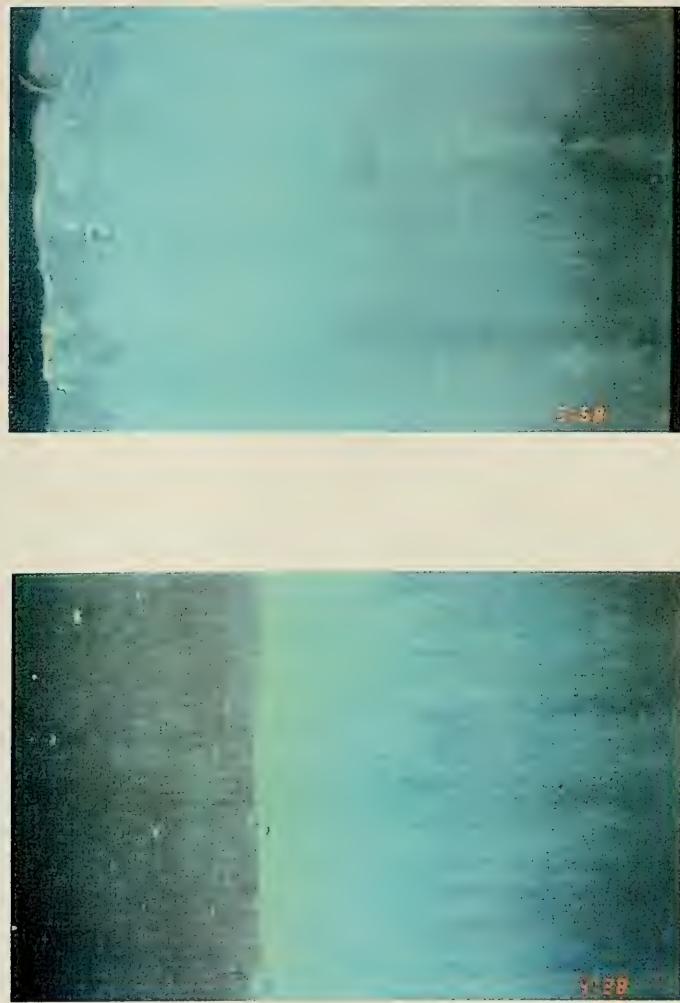
Figure 3-7. Bridgeport Disposal Site REMOTS® photographs from the ambient bottom, Station B22/A, and on dredged material, Station B25/B. The ambient bottom is characterized by biogenically reworked, fine-grained sediments. Dredged material is generally coarser, lower reflectance sediment with some shell fragments. Scale = 0.5×.

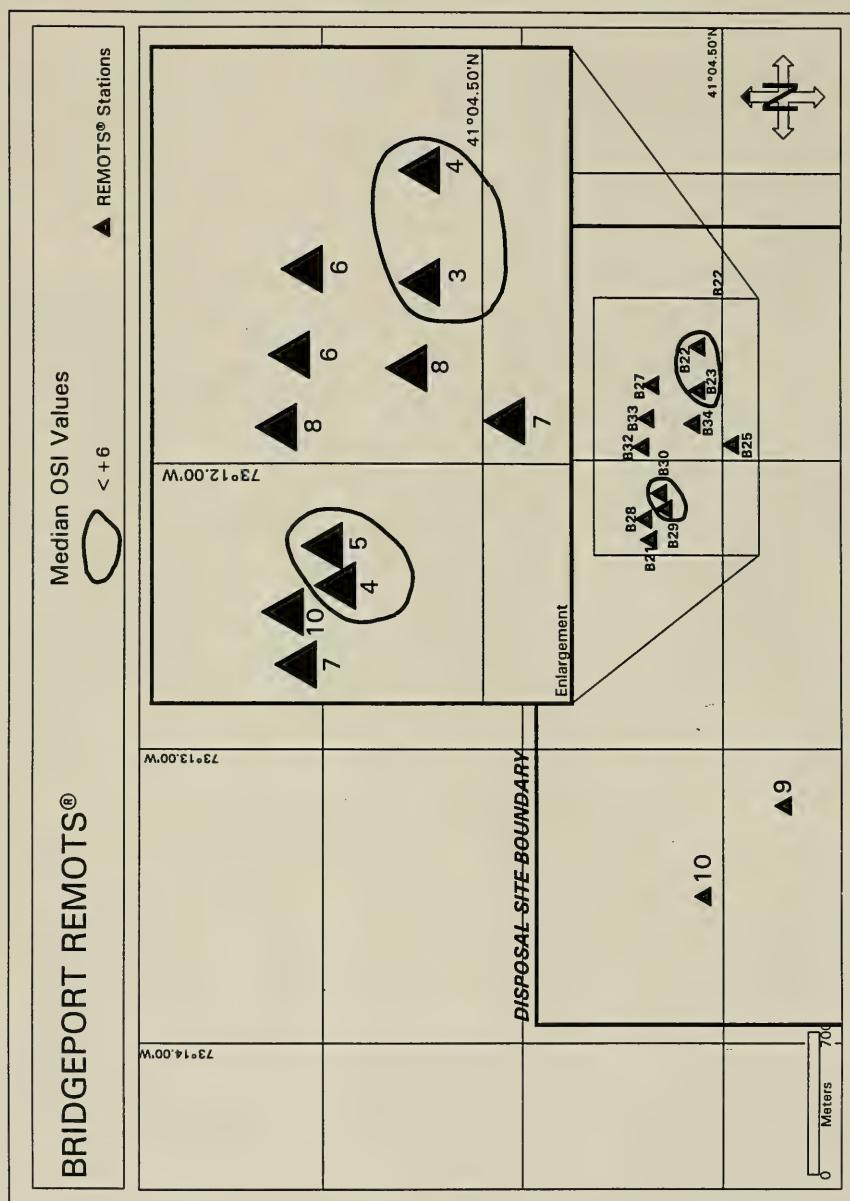
Figure 4-1. Median OSI values at Bridgeport Disposal Site REMOTS® stations

The Organism-Sediment Index (OSI) values reflect both the apparent RPD depths and the infaunal successional status of a REMOTS® photograph. OSI values can range from -10 (no apparent macrofaunal life and methane gas present) to 11 (deep apparent RPD, evidence of mature macrofaunal assemblages, and no apparent methane). Based on other studies, SAIC has determined that OSI values less than or equal to +6 are indicative of a "disturbed" benthic environment (i.e., erosion, dredged material disposal, hypoxia, etc.; Rhoads and Germano 1986). OSI values ranged from +2 to +11 for all replicates with a mean value of +7 for all stations. Among stations, there was no apparent pattern of OSI values. Those stations where dredged material was observed displayed mean OSI values ranging from +3.3 to +10. Mean OSI values for apparent ambient sediments ranged from +3.3 to +9.7. In comparison to mean OSI indices measured in the MQR mound in 1992 (+3 to +7), the range of mean OSI values observed in the Bridgeport Disposal Site fell within and slightly above those measured in the MQR mound. These data suggest disturbances within the Bridgeport Disposal Site were heterogeneous in their distribution.
